# Manhole Inspection Summary

Manhole # S13Q\_\_008MH

**Location** Address: **2807 Wilkens Ave**

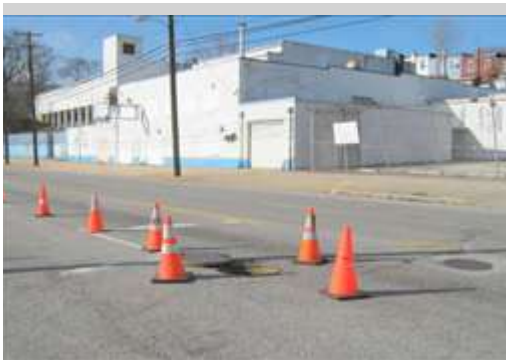
Location View

Across from 2804 Wilkens Ave

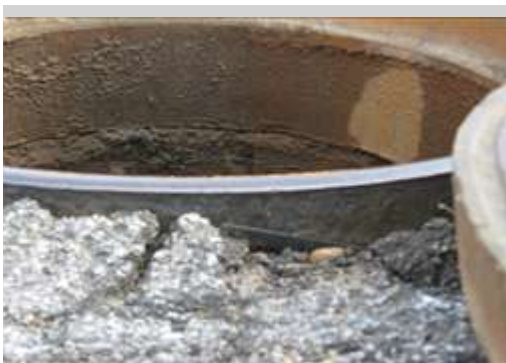
Miscellaneous

A/B Grade 2.5"

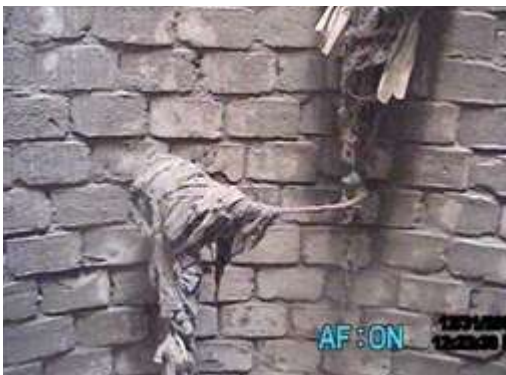
Defect 6

Condition: ☐ Sound ☐ Cracked ☐ Root Intrusion ☐ Loose Brick ☒ **Deteriorated**

Infiltration: ☐ None ☐ Joint ☐ Cracks ☐ Mortar ☐ Roots ☒ **Wall**

infiltration corbel wall

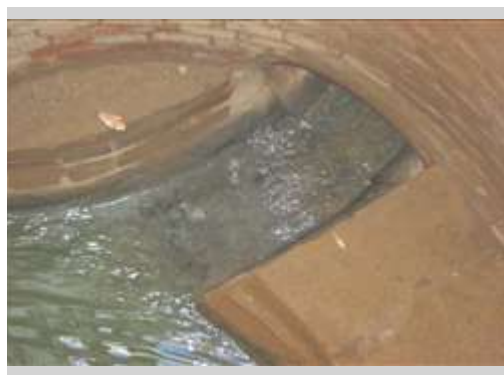
Defect 5

Condition: ☐ Sound ☐ Cracked ☐ Root Intrusion ☐ Deteriorated ☐ Leaks ☒ **Debris**

sludge in I5 channel

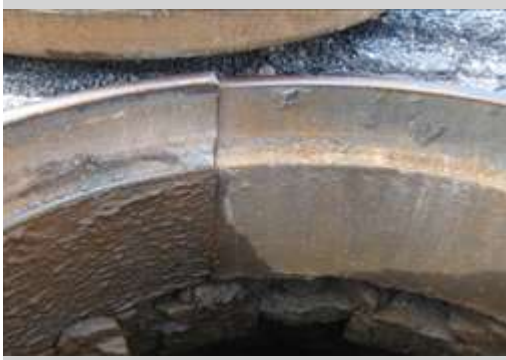
Defect 4

☒ **Cracked**

☒ **Leaks**

cracked frame with infiltration

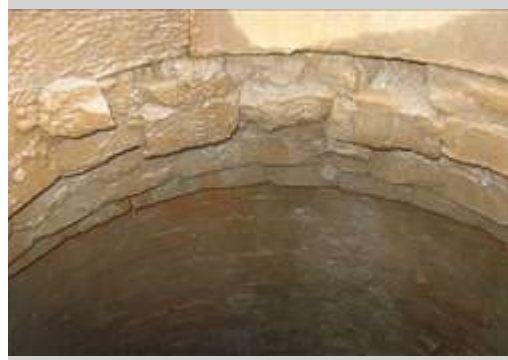
Defect 3

Condition: ☐ Sound ☐ Cracked ☐ Root Intrusion ☒ **Loose Brick** ☐ Deteriorated

Infiltration: ☐ None ☐ Joint ☐ Cracks ☐ Mortar ☐ Roots ☒ **Wall**

cracked frame, loose bricks and infiltration under frame

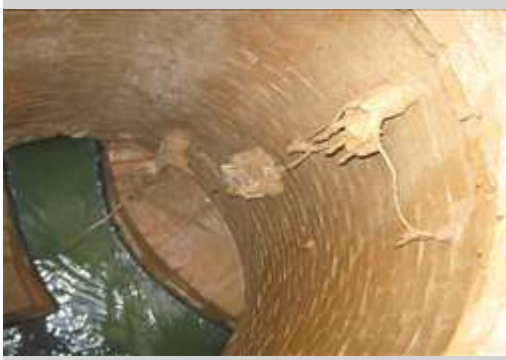
Defect 1

Count: **4** Missing: **2** ☒ **Corroded**

☒ **Evidence Of Surcharge**

Depth: **4** (ft.) ☐ Active Surcharge Present

corroded steps, evidence of surcharge @ 4ft

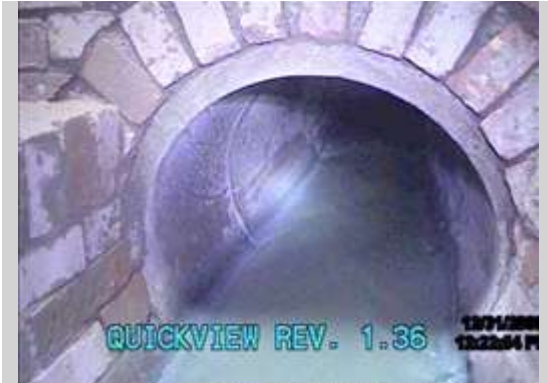
12 O'Clock Outflow

Pipe Height: **18** (in.) Rod and Bar (Angled)  
Pipe Material: **Clay** ☐ Pipe Lined  
Invert Depth: **9.24** (ft.) Flow Characteristics: **Fast**  
Deposits: ☒ None ☐ Mud ☐ Sludge ☐ Debris ☐ Grease  
Silt Depth: **0** (in.) Deposits Extent:  
Infiltration: **None** Pipe Seal Cond: **Sound**

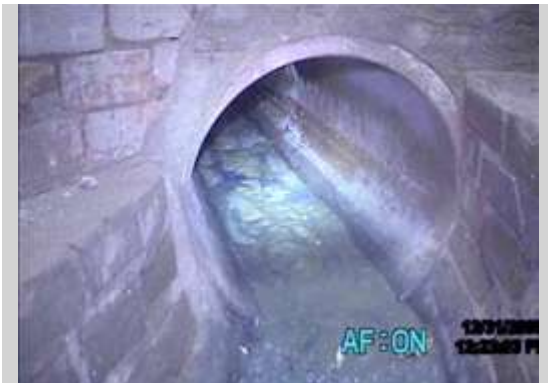
4 O'Clock Inflow

Pipe Height: **15.6** (in.) Rod and Bar (Angled)  
Pipe Material: **Clay** ☐ Pipe Lined  
Invert Depth: **8.96** (ft.) Flow Characteristics: **Fast**  
Deposits: ☒ None ☐ Mud ☐ Sludge ☐ Debris ☐ Grease  
Silt Depth: **0** (in.) Deposits Extent:  
Infiltration: **None** Pipe Seal Cond: **Sound**

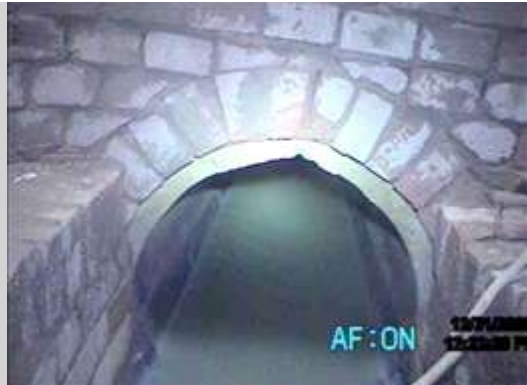
7 O'Clock Inflow

Pipe Height: **18** (in.) Rod and Bar (Angled)

Pipe Material: **Clay** ☐ Pipe Lined

Invert Depth: **9.23** (ft.) Flow Characteristics: **Fast**

Deposits: ☒ None ☐ Mud ☐ Sludge ☐ Debris ☐ Grease

Infiltration: **None** Pipe Seal Cond: **Sound**
